C208

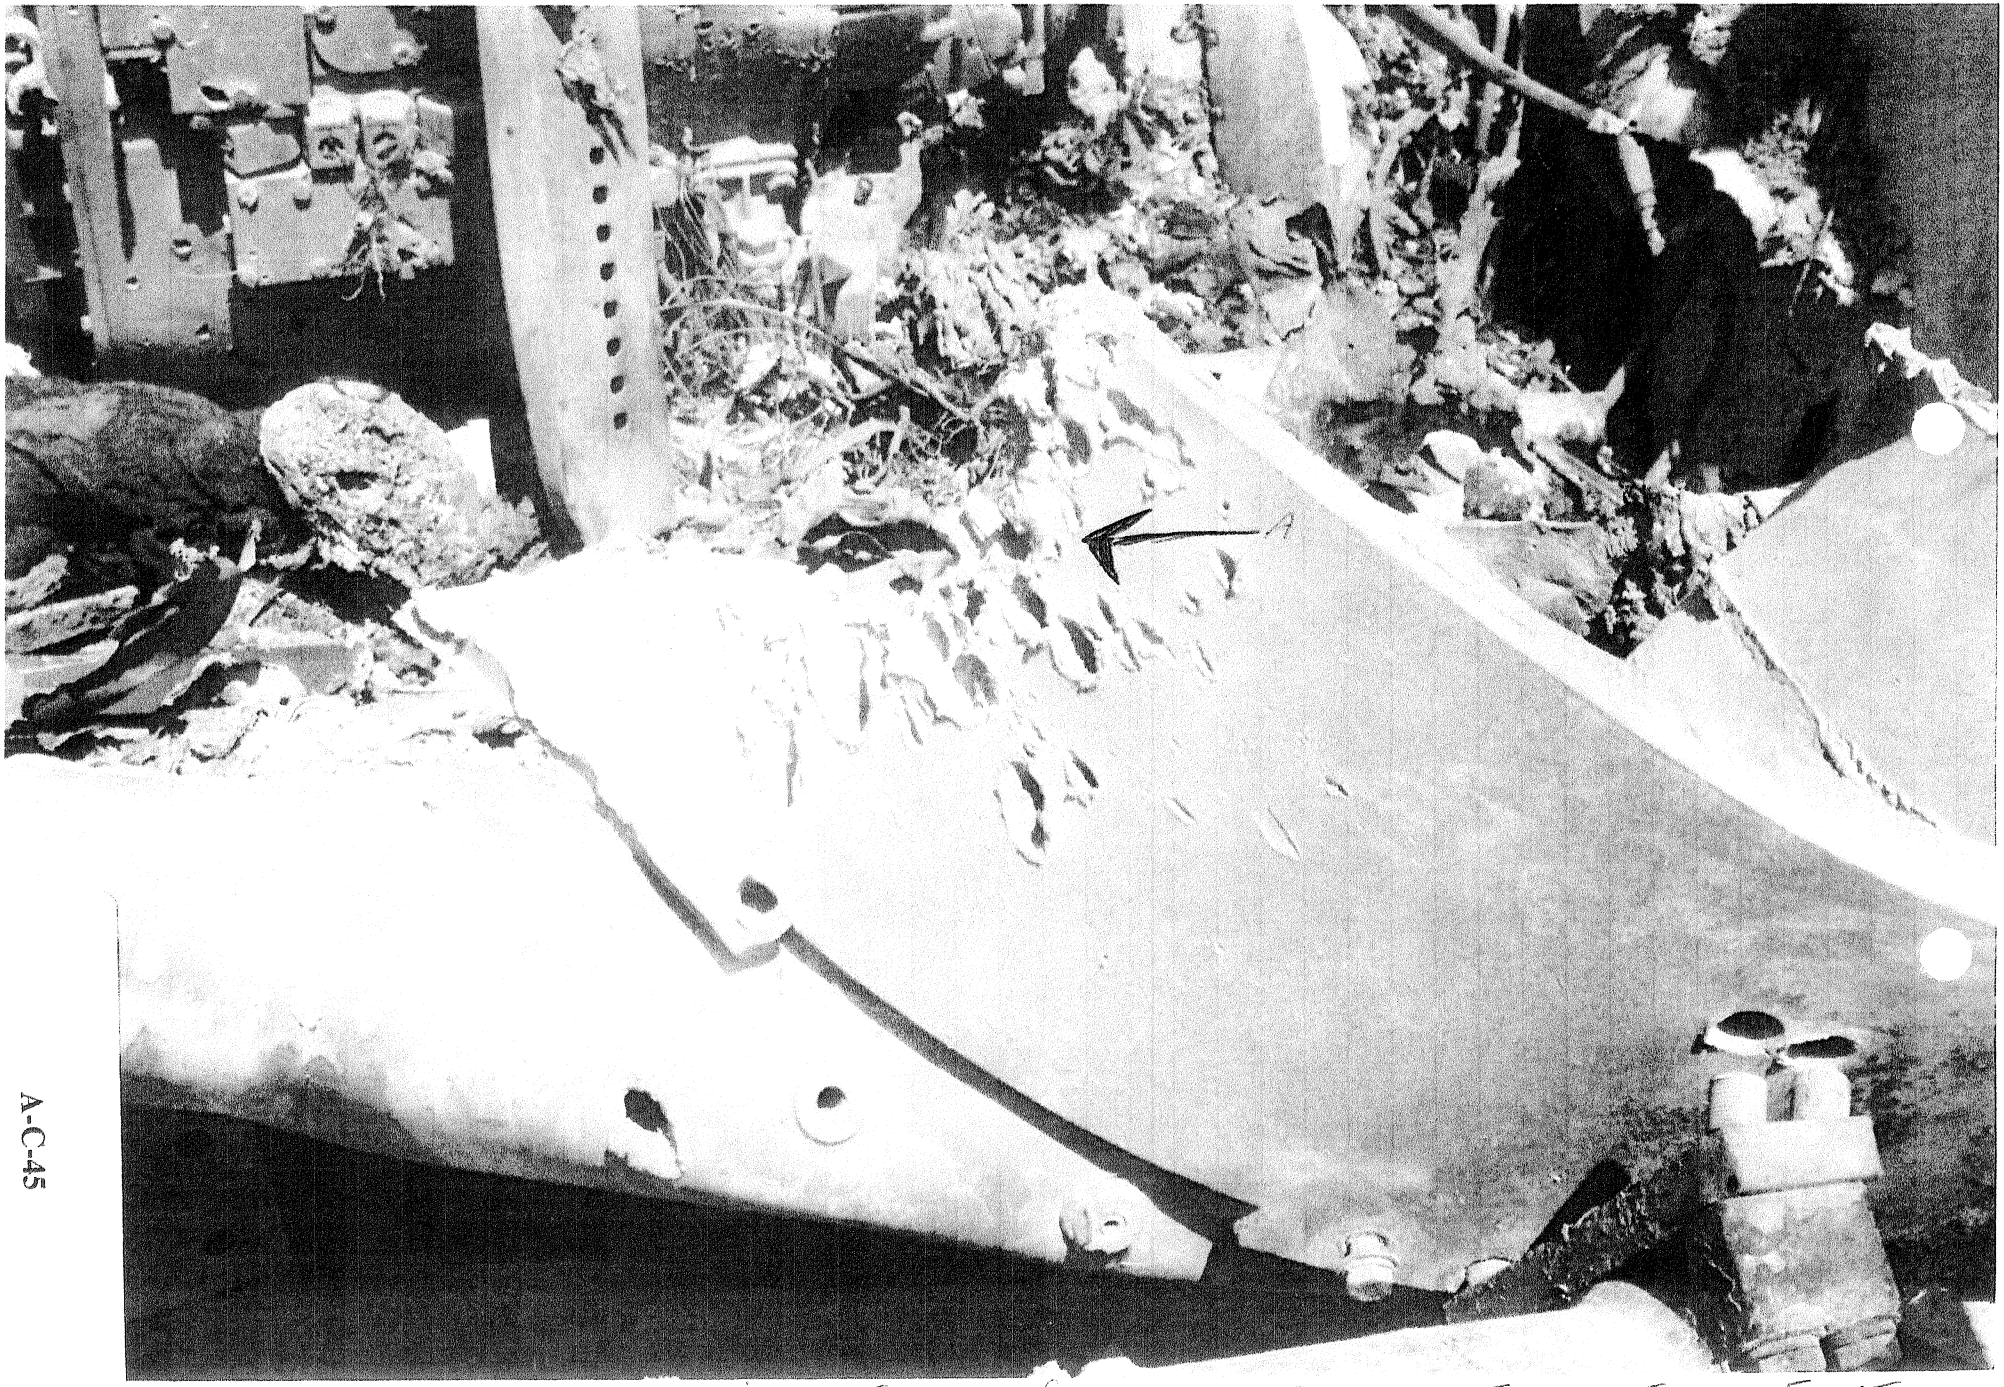
LARGE ENTRY HOLE IN RIGHT FRONT OF VEHICLE. DIRECT FIRED FROM FRONT OF VEHICLE TO REAR
